Evaluation of Nondestructive Methods for Determining Pavement Thickness

Lulu Edwards and Quint Mason

September 2011

Final report

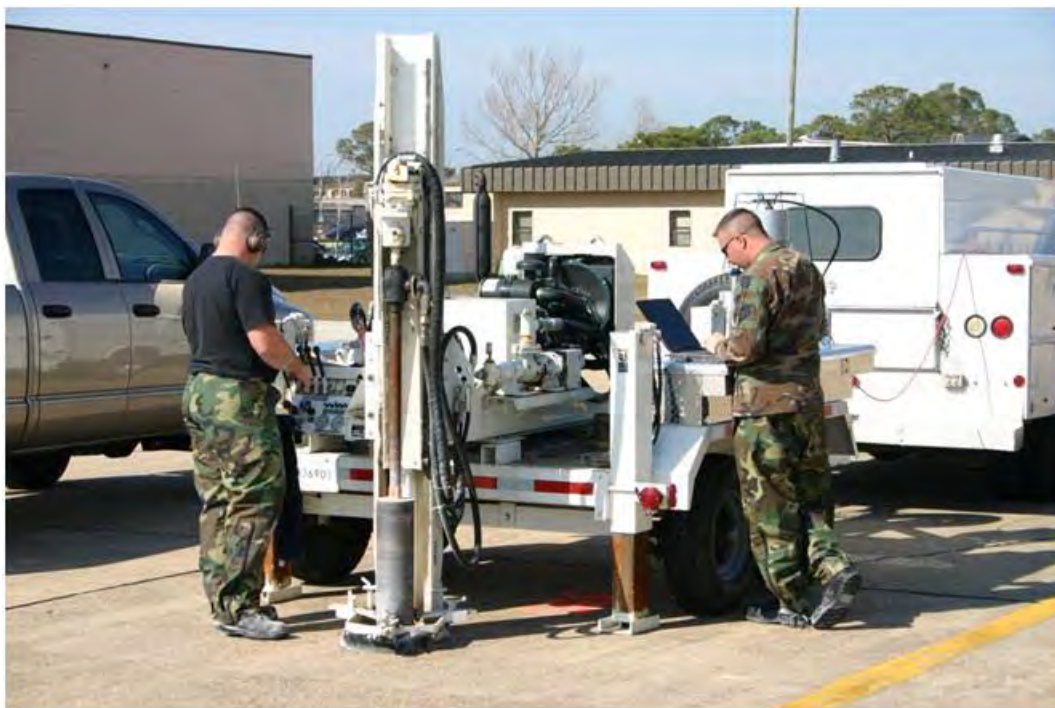
Figure 1. Current method of extracting cores during an airfield evaluation.

The ERDC was tasked by the U.S. Air Force (USAF) to evaluate emerging nondestructive thickness measuring devices to determine their ability to accurately estimate pavement surface thickness without requiring large footprint equipment or repairs. The USAF must operate anywhere in the world that supports our nation's objectives. In order to support deployments, existing airfields must be evaluated for their potential suitability for use, and accurate estimates of their performance capability must be made. The Airfield Pavement Evaluation (APE) team of the USAF is tasked with deploying to airfields of interest, often with minimal resources, and quickly evaluating the condition and structural capacity of the airfield pavement infrastructure. The pavement surface thickness is a critical component of the data needed to accurately assess the structural capacity of the pavement. Currently, the APE team must core the pavement to determine its thickness. Coring is a destructive data collection method that requires bulky equipment, a water source, and patching materials to repair the hole left in the pavement (Figure 1).

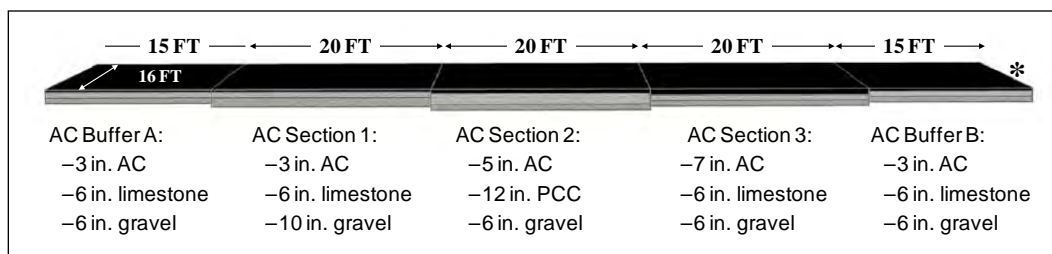
Figure 2. Layers of the AC portion of the custom test section. The * denotes where the AC and PCC sections connect.

A 16-ft-wide custom test section was constructed of AC and PCC to provide a range of thicknesses found on airfields. Each section was 20-ft long with 15-ft buffers between the AC (Figure 2) and PCC sections (Figure 3), so the AC and PCC section were a total of 90-ft long. Twenty test points, ten AC points, and ten PCC points were located in the custom test section at the

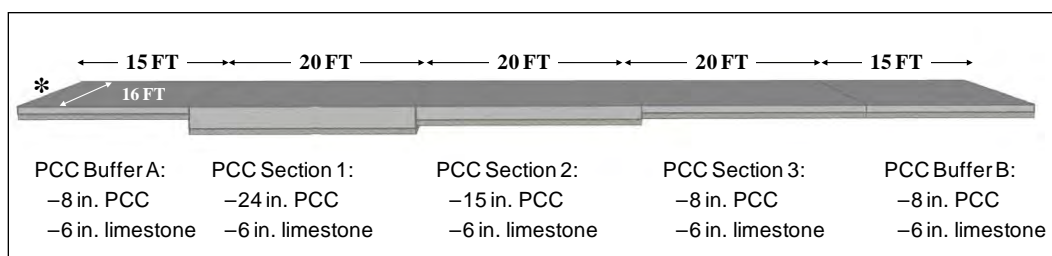
Figure 3. Layers of the PCC portion of the custom test section. The * denotes where the AC and PCC sections connect.

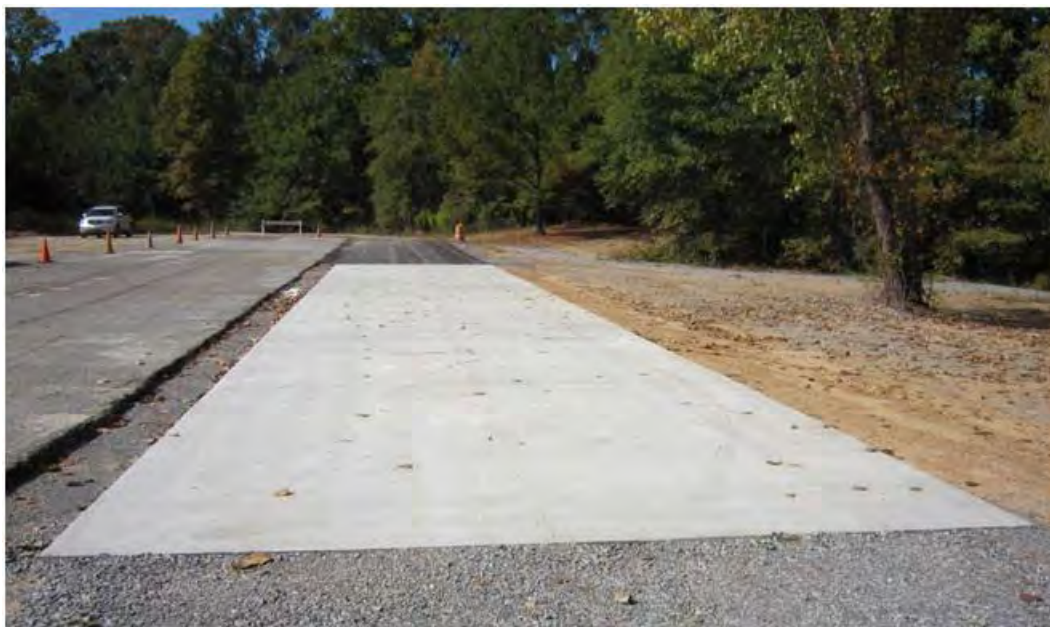
Figure 4. Overview photo of the custom test section constructed at the Poor House Test Area.

Poor House Test Area (Figure 4). Three points were chosen for each thickness and a calibration point was chosen in the buffer zone for both the AC and PCC sections.

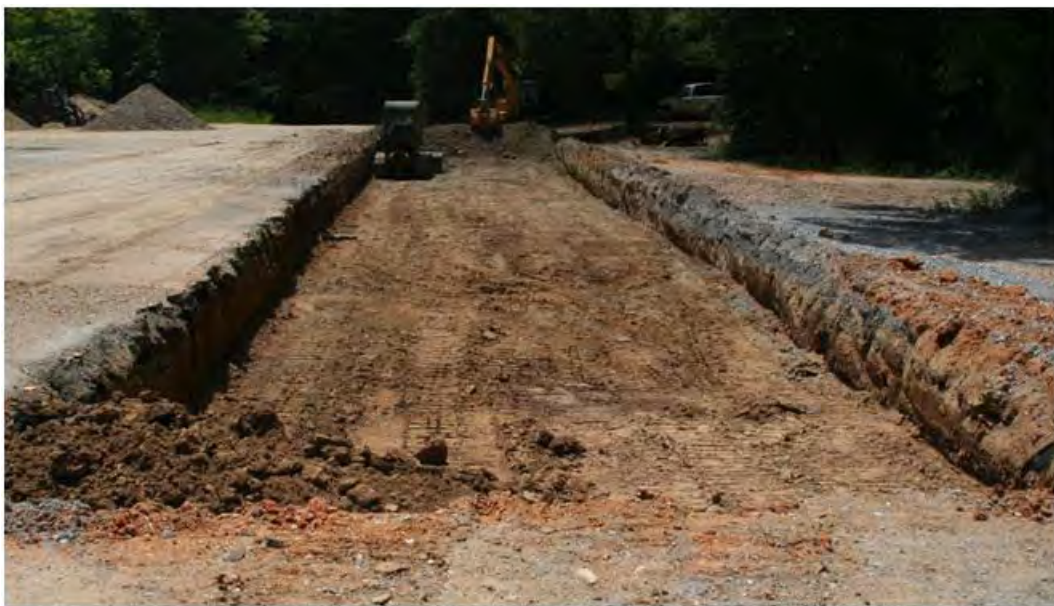
Figure 5. Excavation for test site construction preparation.

The site for the custom test section was cleared of existing vegetation, and a prior test section was removed (Figure 5). The existing subgrade was leveled, prior to construction. A geotextile was placed on the subgrade, prior to placing the subbase and base layers (Figure 6). Drainage was also constructed in the center of the section (Figure 7). For both the AC and PCC sections, crushed limestone was used as the base, and clay gravel was used for the subbase. One lift of the crushed limestone was placed and compacted with a steel-wheel vibratory roller. The source for the crushed limestone was a 610 limestone base.

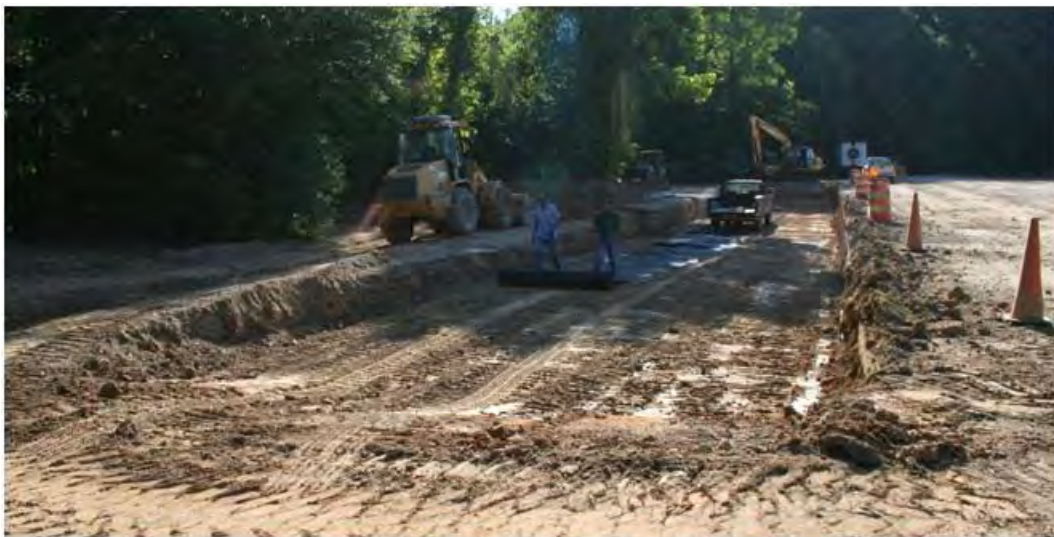
Figure 6. Geotextile placement on top of subgrade.

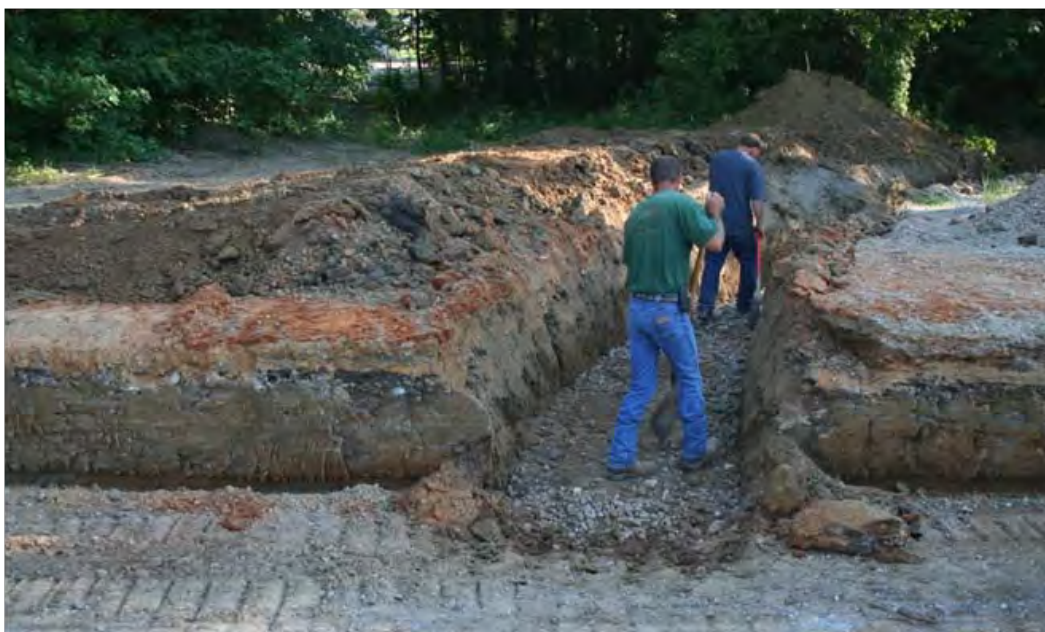
Figure 7. Drainage construction.

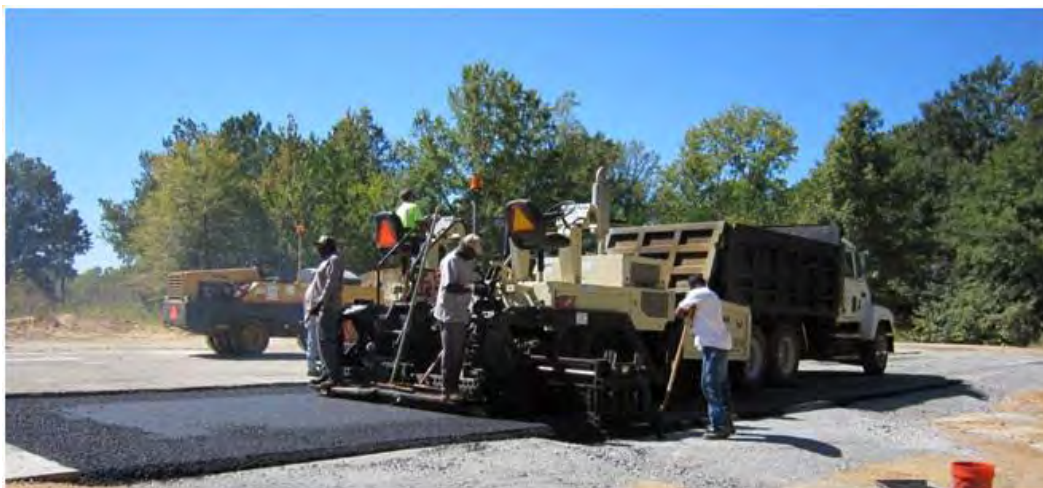
Figure 8. Asphalt placement.

roller (Hyster C530A). Density was measured with the Troxler nuclear moisture-density gauge and was determined to be adequate for the purposes of this test (Table 6). Figures 8–10 show the construction phases of the AC test section.

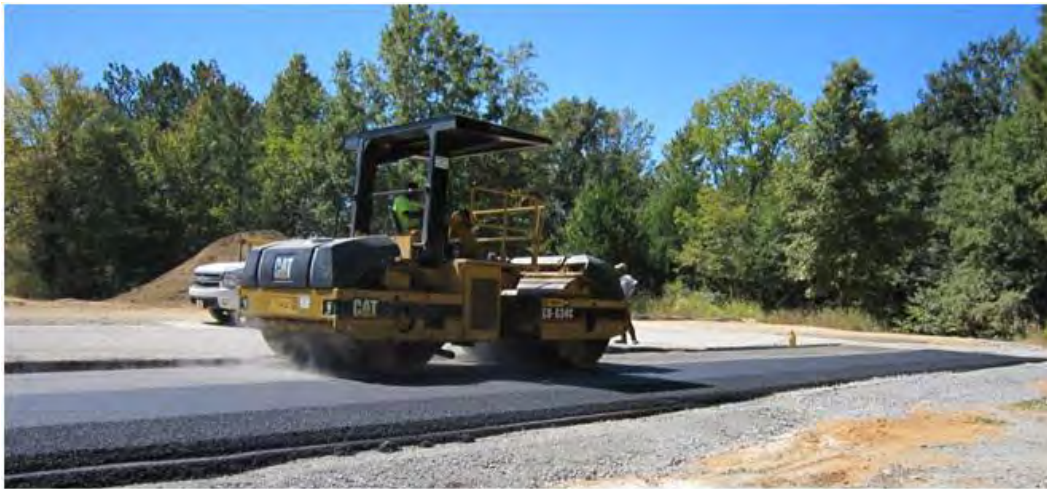
Figure 9. Compaction with a double drum vibratory compactor.

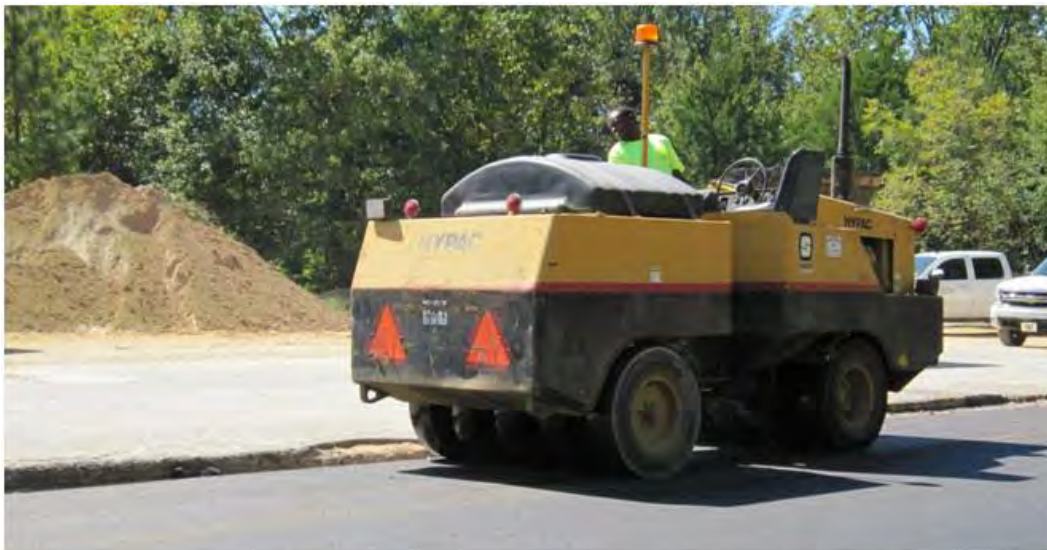
Figure 10. Compaction with a rubber tire roller.

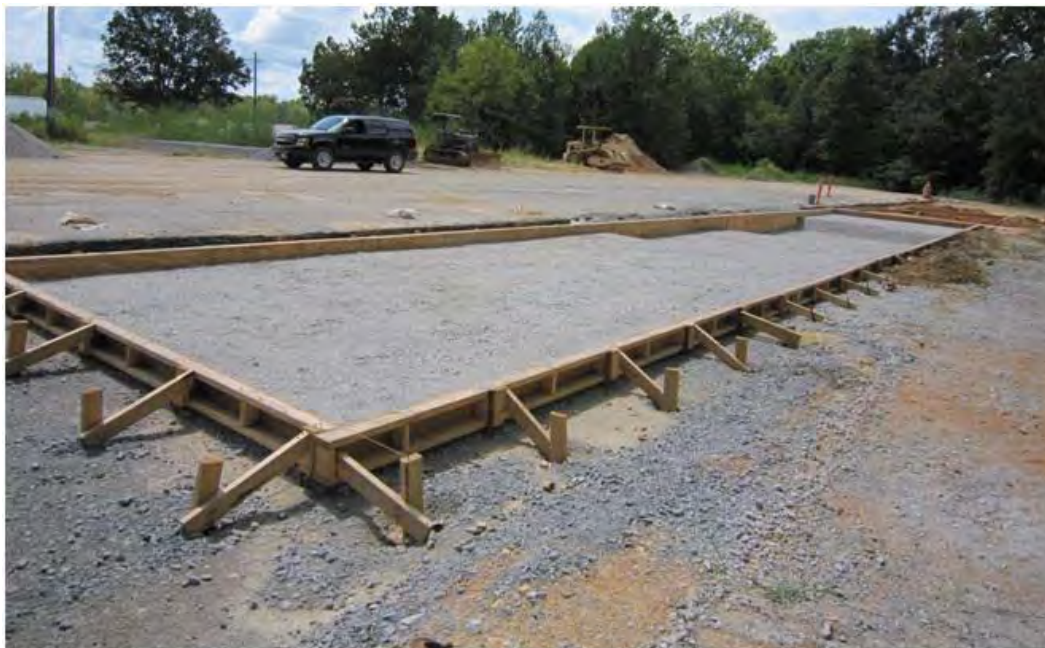
Figure 11. Forms for the PCC placement.

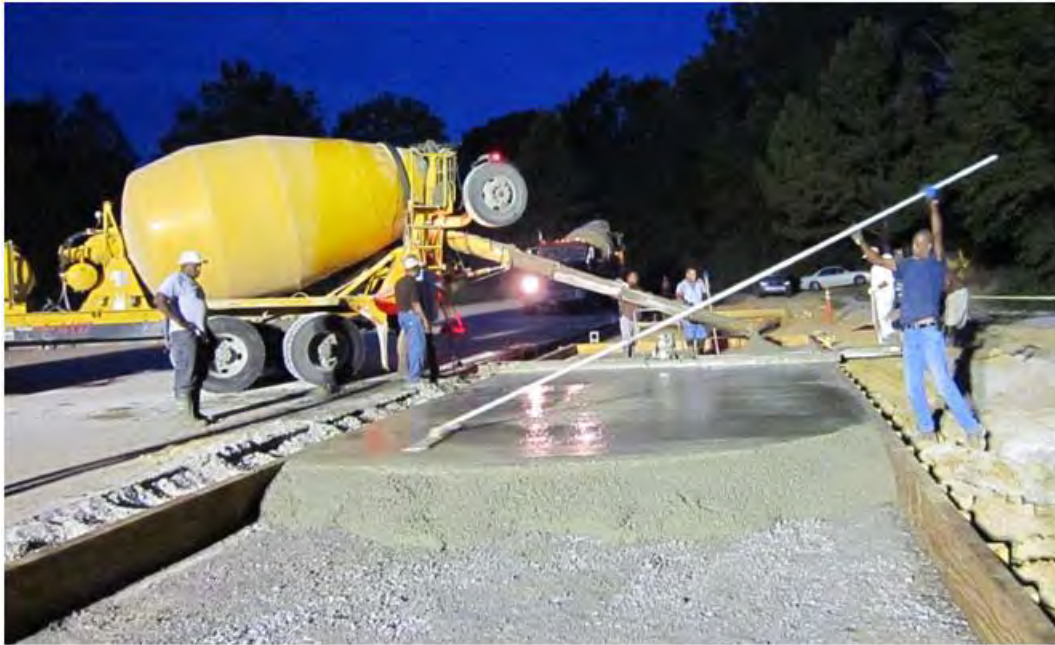
Figure 12. PCC placement.

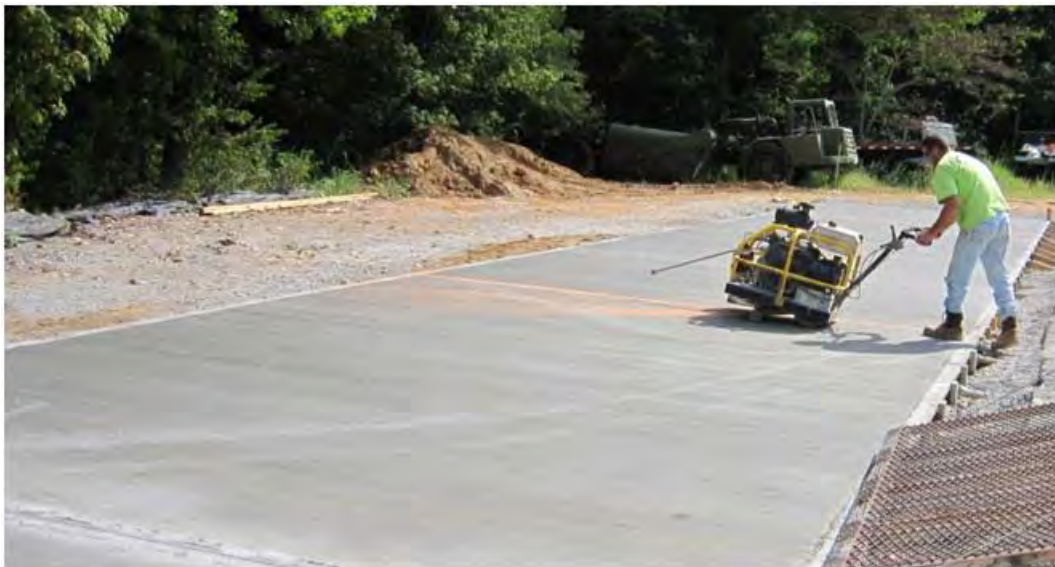
Figure 13. Saw cutting.

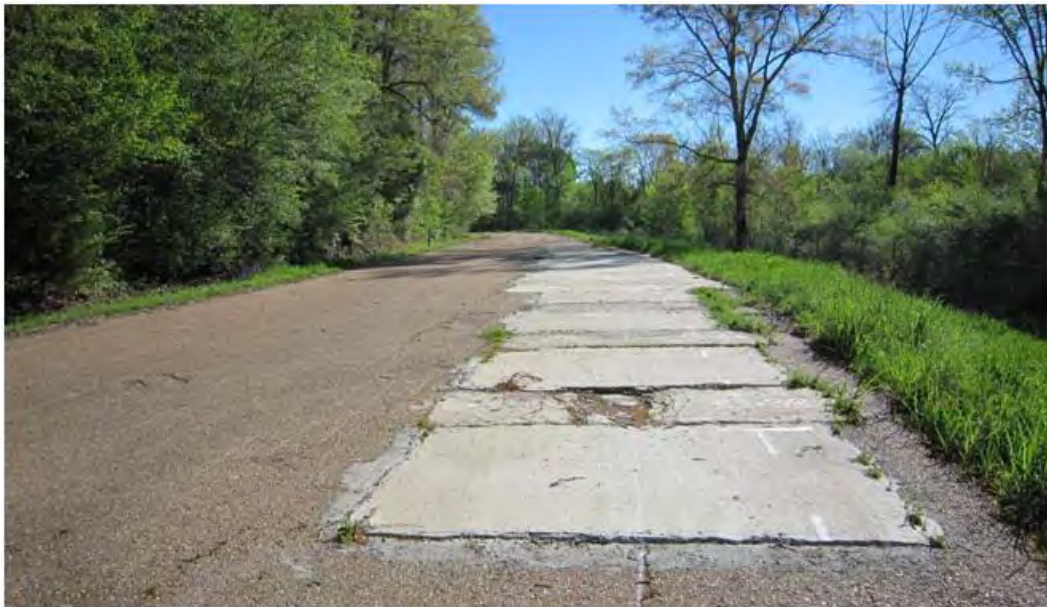
Figure 15. The flowable fill section is shown here on the right and was located within the Forest Service Road.

In 2010, a section of the Forest Service Road was utilized for a research project on flowable fill (Figure 15). During this project, the existing AC pavement and base course were removed, and either flowable fill or well-graded gravel was placed on the existing subgrade with a 6- to 8-in. PCC layer on top. Four test points and one calibration point were selected from this section to use for testing.

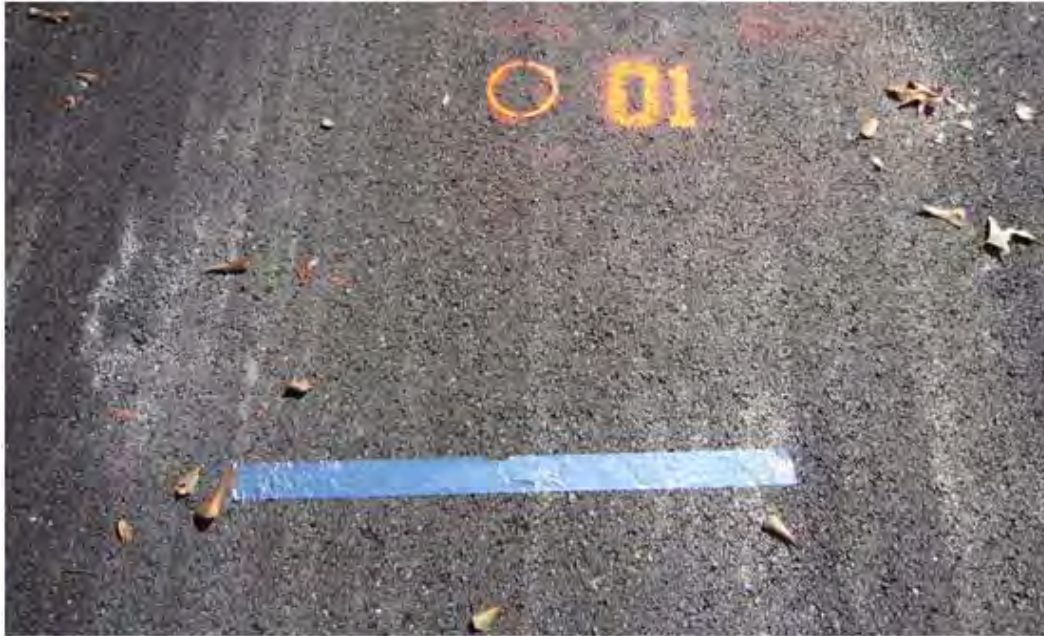
Figure 16. Test location marked with a circle to indicate location of the core hole and metallic tape spaced 2 ft away from the center of the core hole.

circle. This metallic tape can be seen in the GPR signal and enables the user to locate test points.

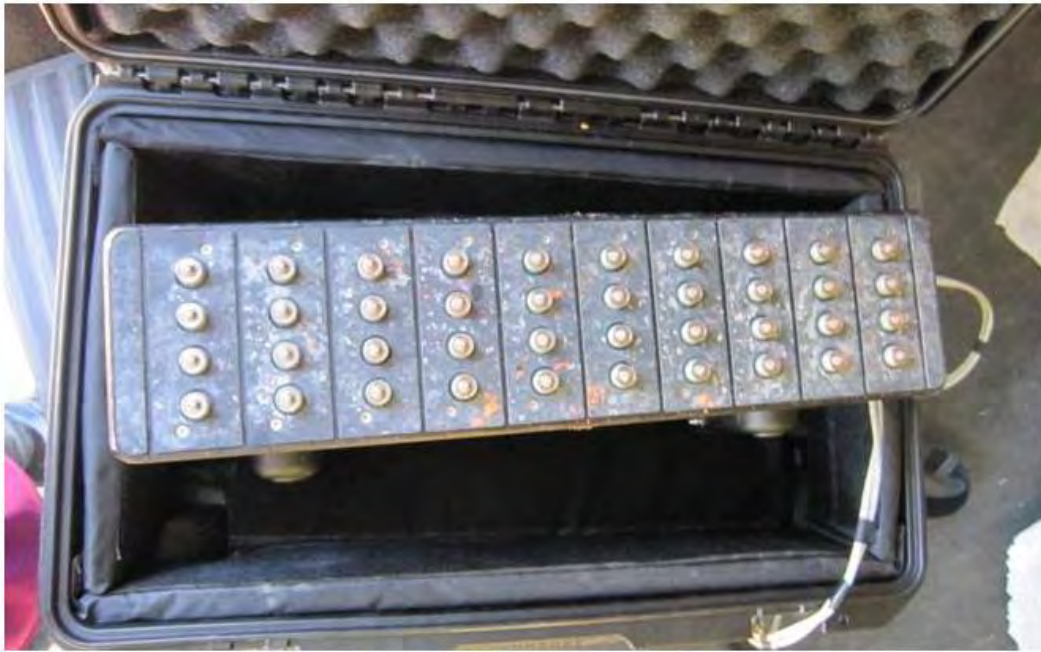
Figure 17. Bottom of the MIRA device, where the 40 transducers are located.

The MIRA is an ultrasonic pulse-echo device that is able to penetrate concrete and reveal structures or layers in the concrete in real-time. It has been primarily used for concrete imaging applications to nondestructively view objects such as holes, cracks, and reinforcement bars within the concrete. It operates in a frequency range of 20-100 kHz, and at an average frequency of 50 kHz. The MIRA can reportedly measure a range of thicknesses from 50 mm to 1 m (1.97 in. to 3.28 ft). Near real-time thickness measurements can be obtained with this device. This device consists of 40 transmitting and receiving dry point contact (DPC) transducers on the bottom of the device, as shown in Figure 17. There are 45 transmitting and receiving transducer pair measurements that allow for redundancy to confirm measurements when measuring heterogeneous materials such as PCC and asphalt. The device is adaptable to rough surfaces because each transducer has a wear-resistant ceramic pin and independent spring load. A single measurement takes 3 sec, and the DPC transducers can measure up to 1-m deep (3.28-ft). The weight of the antenna array is 6.5 kg (14.3 lb), and the weight of the entire system (antenna array, laptop, and power source) is 15 kg (33 lb).

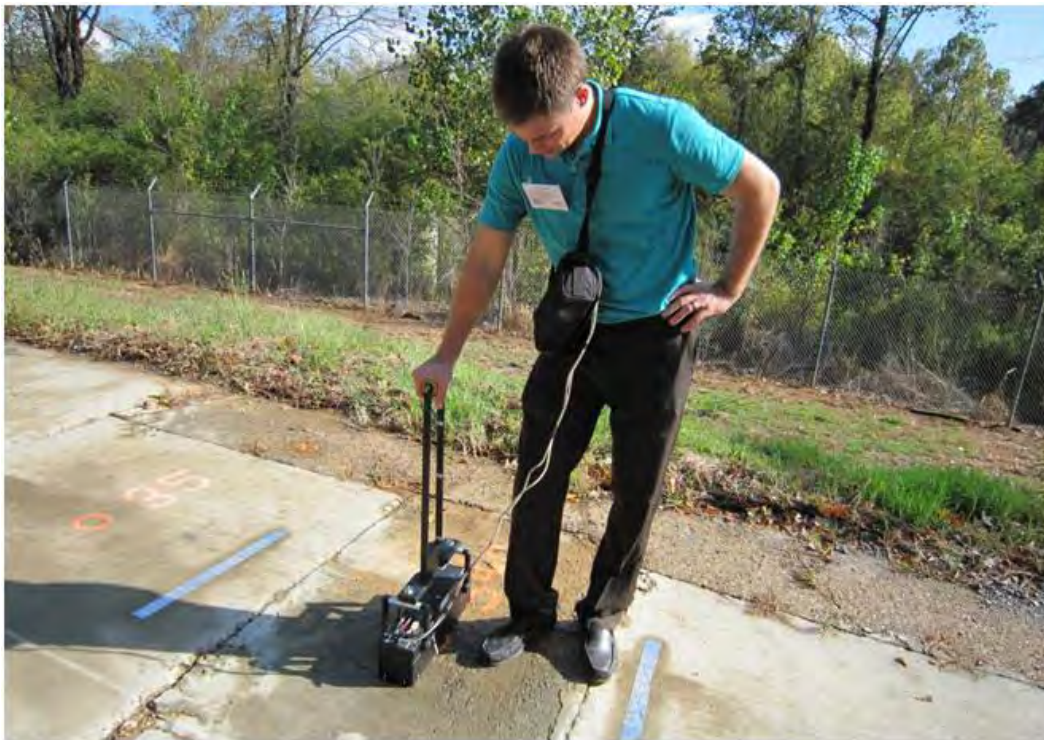
Figure 18. Testing a PCC slab with the MIRA.

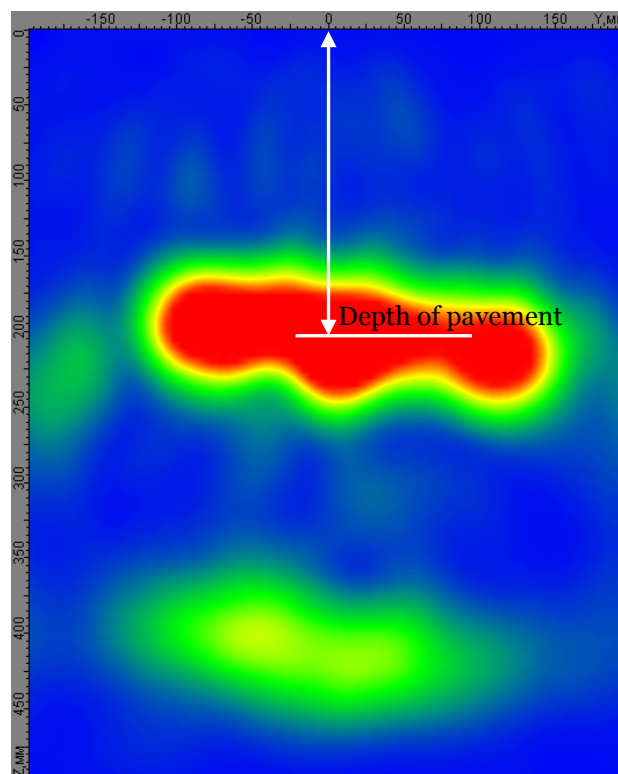
Figure 19. B scan from the MIRA scanner for location 20.

During the testing, near real-time thickness measurements were provided for the PCC locations. The layer interface generates a change in the signal, which can be seen in the B-scan representation of the data (Figure 19). The B-scan is a representation of the pavement, with the horizontal axis representing the surface of the pavement, and the vertical axis representing depth of the pavement. Thickness measurements were extracted by using the software provided by Acoustic Control Systems, Ltd. Thickness measurements were determined by using the measurement tool in the software and measuring distance from the surface to the centroid of the bright spot.

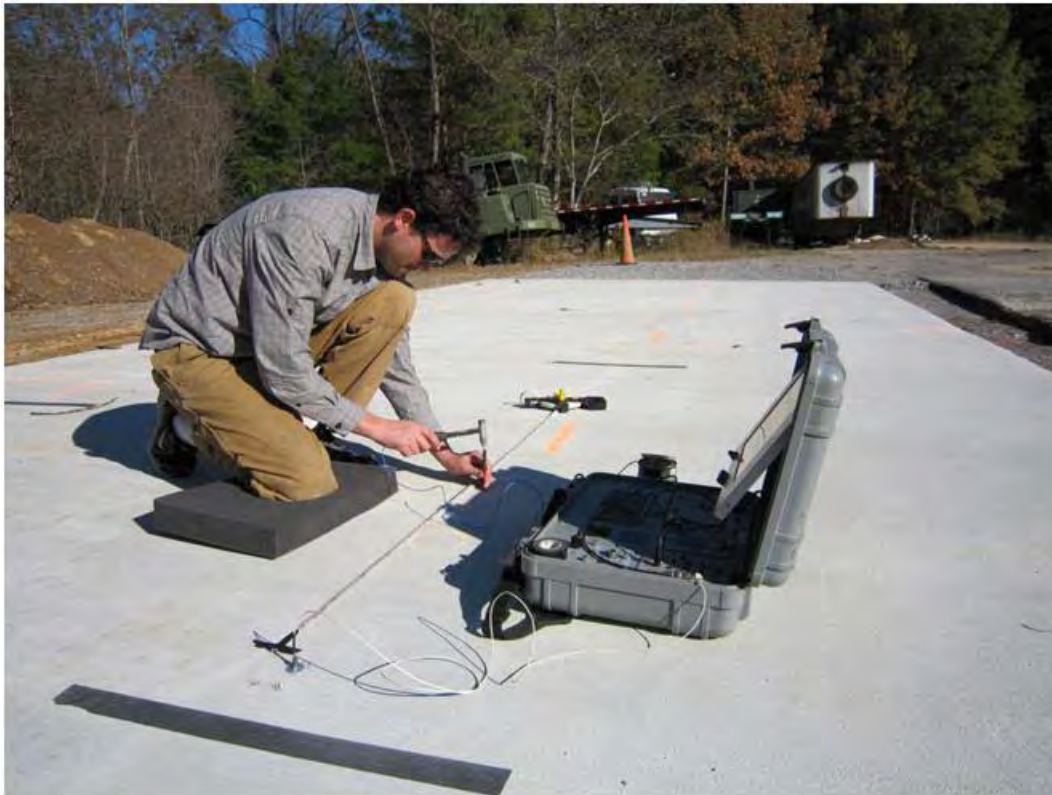
Figure 20. MISW testing.

Olson Engineering performed a thickness estimation of the pavement test locations with the multiple impact surface waves (MISW) method on 2 December 2010 (Figure 20). The MISW method estimates the surface wave velocity of layered systems along the depth by using the dispersive characteristics of surface waves (Olson et al. 2010). MISW equipment consisted of a measuring tape, 3.2-oz instrumented hammer, seismic accelerometer, Olson Instruments Freedom Data PC computer, and lithium based grease. Each test, including the setup of the test, took approximately 10 to 15 min. All of the equipment had to be moved from location to location, which increased the total testing time.

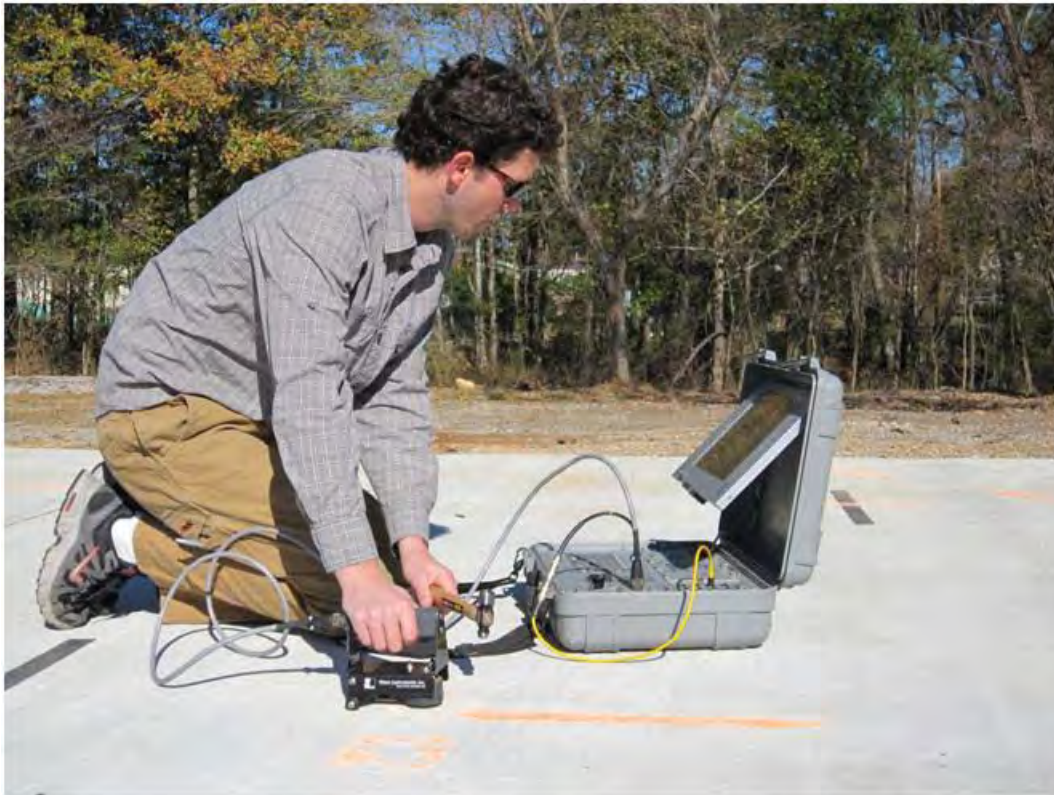
Figure 21. Impact echo testing.

The impact echo method (Figure 21) can be limited for pavements less than 3-in. thick because high frequencies generated by the impact are required.

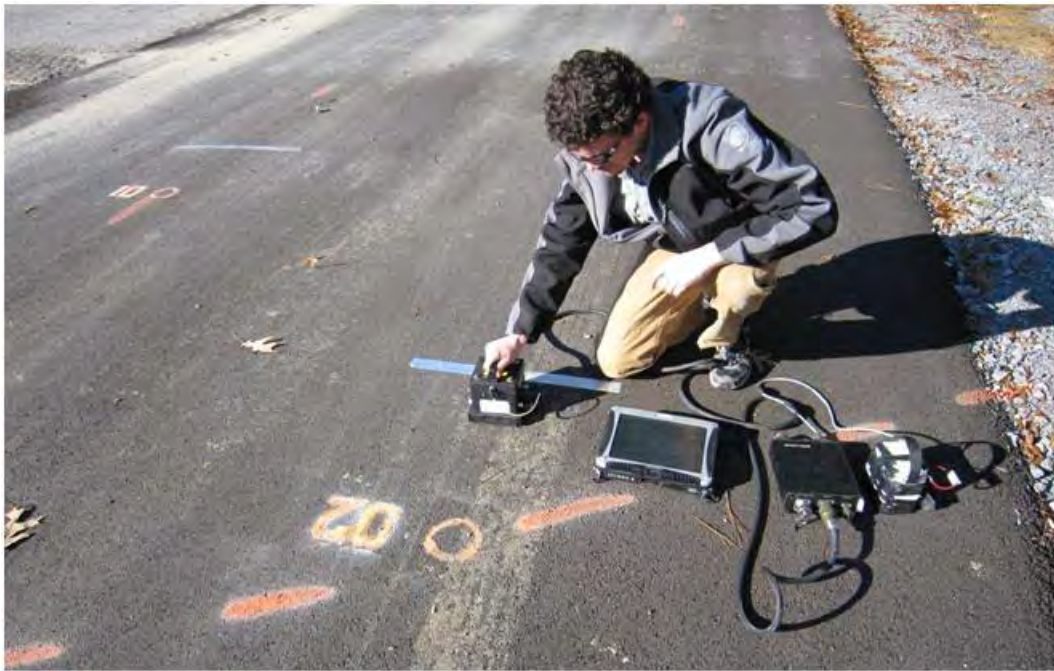
Figure 22. 2-GHz Ground-Coupled IDS Aladdin GPR (Olson Engineering) testing.

As with other GPR systems, the thickness of the pavement is found by sending electromagnetic wave pulses into the pavement and measuring the time the pulse takes to reflect back. If the pavement material has a change in its dielectric constant, a portion of electromagnetic wave will reflect back to the antenna, and the remaining wave will travel further down. The IDS GPR system sends out approximately 60 pulses per ft.

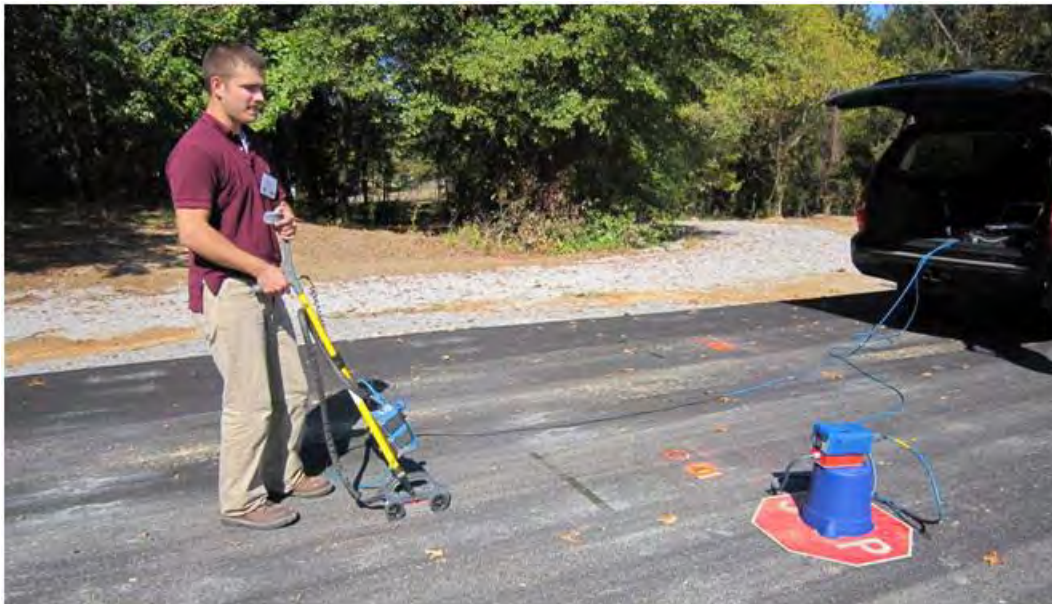
Figure 23. Single 1.5-GHz ground-coupled GPR testing.

Infrasense evaluated the pavement on 21 October 2010 using a single ground-coupled antenna with an addition that is not normally seen with the ground-coupled antenna, side-by-side metal plate calibrations. The 1.5-GHz ground-coupled antenna and a SIR-20 controller from Geophysical Survey Systems, Inc. (GSSI) of Salem, NH were used. This antenna can reportedly penetrate up to 20 in. in AC, but penetration will vary in PCC as this material attenuates GPR signal. The antenna was attached to a cart equipped with a Distance Measuring Instrument (DMI), also provided by GSSI, to assist in the ease of data collection (Figure 23). The SIR-20 controller remained in the survey vehicle. Data were collected at a rate of 40 scans per ft, and an electronic trigger was activated as the antenna traveled over the test location. As an experiment, side-by-side metal plate calibrations were run every time there was a change in pavement type or thickness to estimate the dielectric constant of the pavement; however, these data were not used in the post-processing for this study. Testing took approximately 2 min if running a side-by-side plate calibration, and less than 1 min if running a test only.

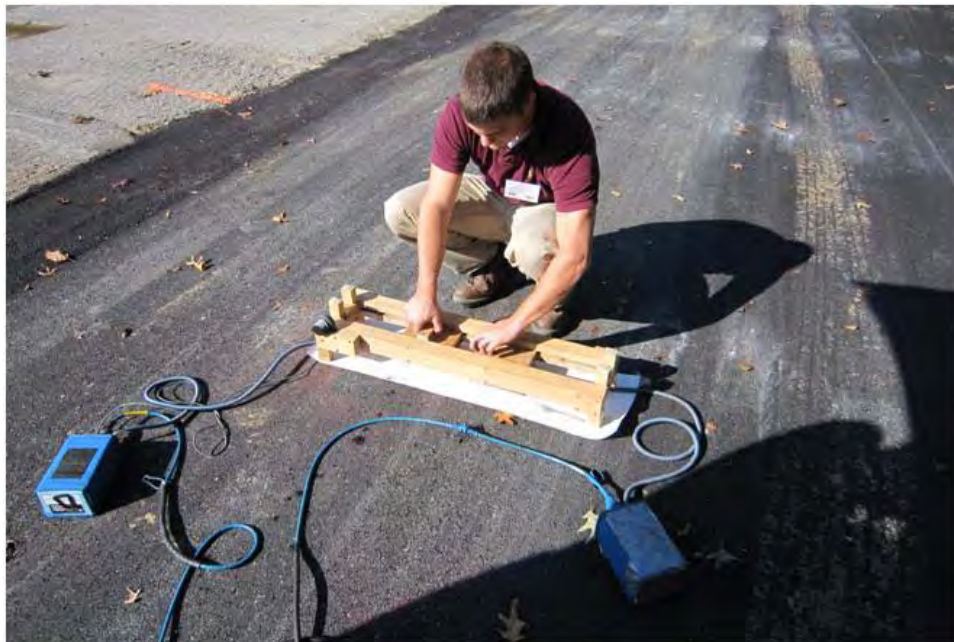
Figure 25. Common midpoint testing using two 1.5-GHz GSSI antennas.

Infrasense also tested with the common midpoint (CMP) method using two 1.5-MHz ground-coupled antennas and a SIR-20 controller from GSSI. This method consisted of the two antennas, a controller, a wooden frame to hold the antennas, a plastic sheet to aid in the movement of the antennas, and a DMI (Figure 25). It took about 2 to 5 min to acquire data for a single location using this method. Extensive post-processing was required after the data collection.

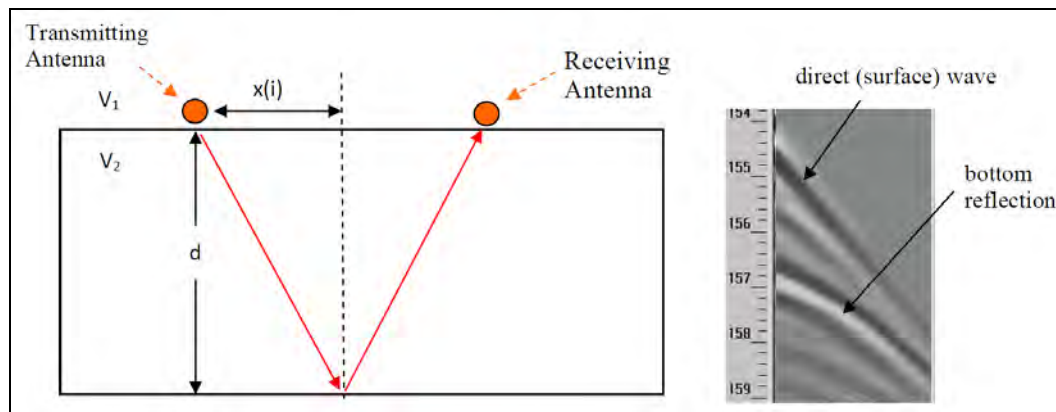
Figure 26. Description of the variables in the CMP method and the hyperbolic pattern generated by the GPR signal (figure taken from Infrasense, Inc. 2010).

$$t_{tot}(i) = \frac{2}{V_2} \sqrt{x(i)^2 + d^2} \quad (4 \text{ bis})$$

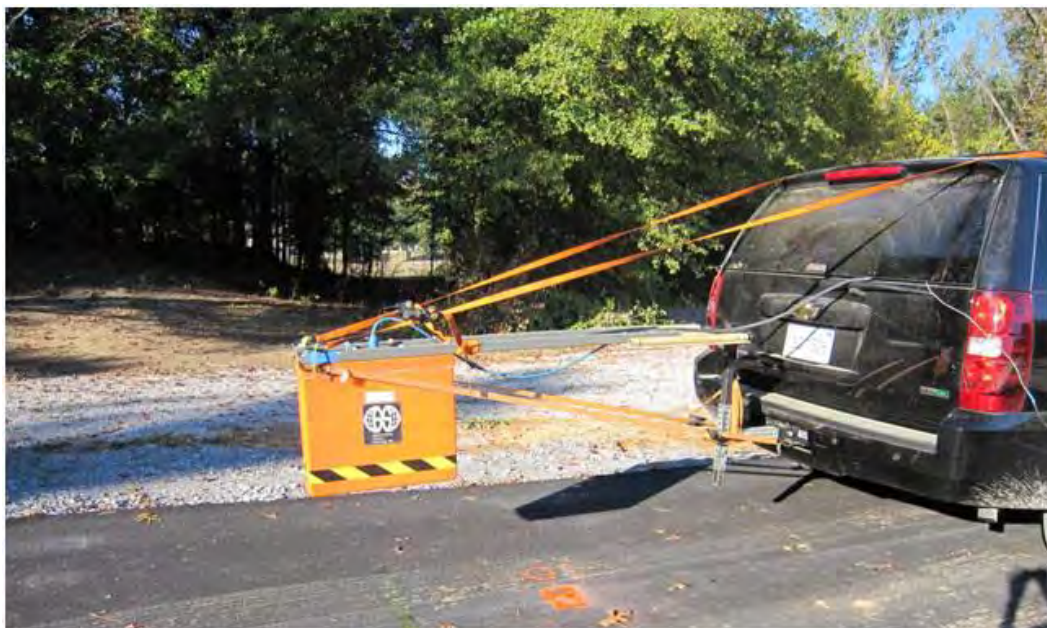
Figure 27. Infrasense testing of GSSI 1-GHz horn antenna.

The final method Infrasense used for the pavement evaluation on 21 October 2010 was a 1-GHz GSSI air-coupled horn antenna (Figure 27). Setup of the horn antenna required attaching the antenna to the rear of the vehicle and connecting the cables. Setup required approximately 30 min, but the actual testing of each test point was very quick to execute (<10 sec) because all that was required was that the horn antenna be driven over the test locations. Test points within an area could be collected during one pass with this system as long as the points were in a straight line. To determine the dielectric constants, a metal plate calibration was completed, prior to testing. Additionally, a bounce test to account for the changes in antenna height was completed, prior to testing, to enhance the data processing later. The bounce test consisted of standing on the back of the vehicle and making the antenna bounce. The metal plate calibration and bounce test took approximately 15 min.

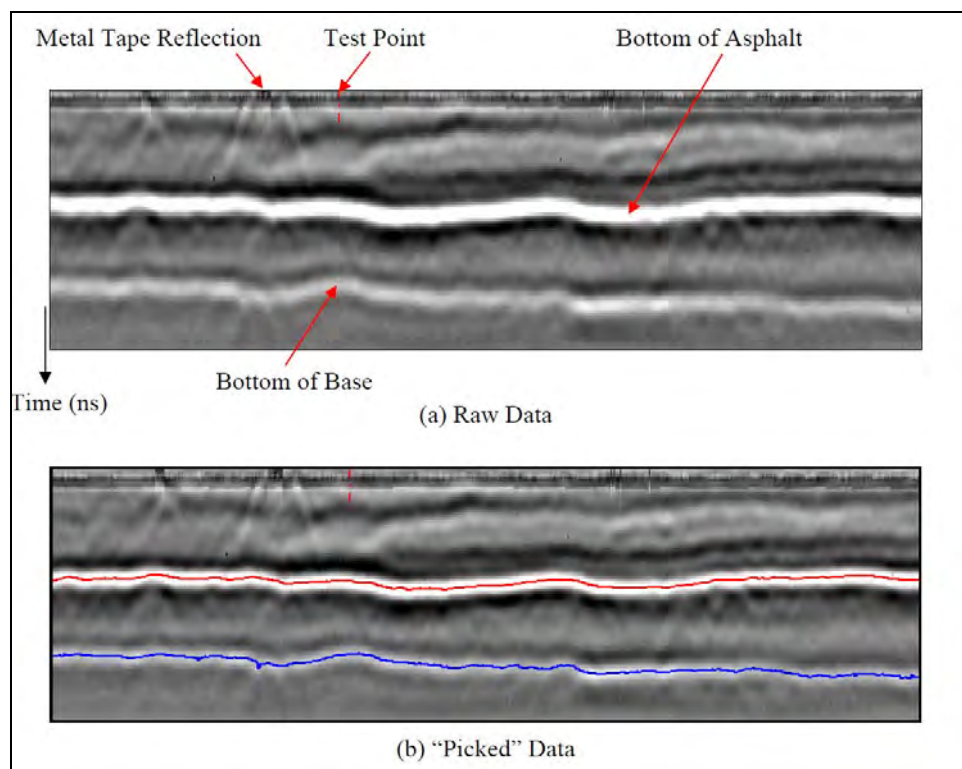
Figure 28. Data from the 1-GHz horn antenna at test location 30 (figure taken from Infrasense, Inc. 2010).

Data were processed using *winDECAR*®, the custom software developed by Infrasense. Sample data, from test location 30, are shown in Figure 28. These data have been processed by the software and a GPR analyst to show only two layer interfaces, the bottom of the AC layer and the bottom of the base, as white bands. The dielectric constant and thicknesses of the pavement layers are calculated by the software for the picked layers (Infrasense, Inc. 2010).

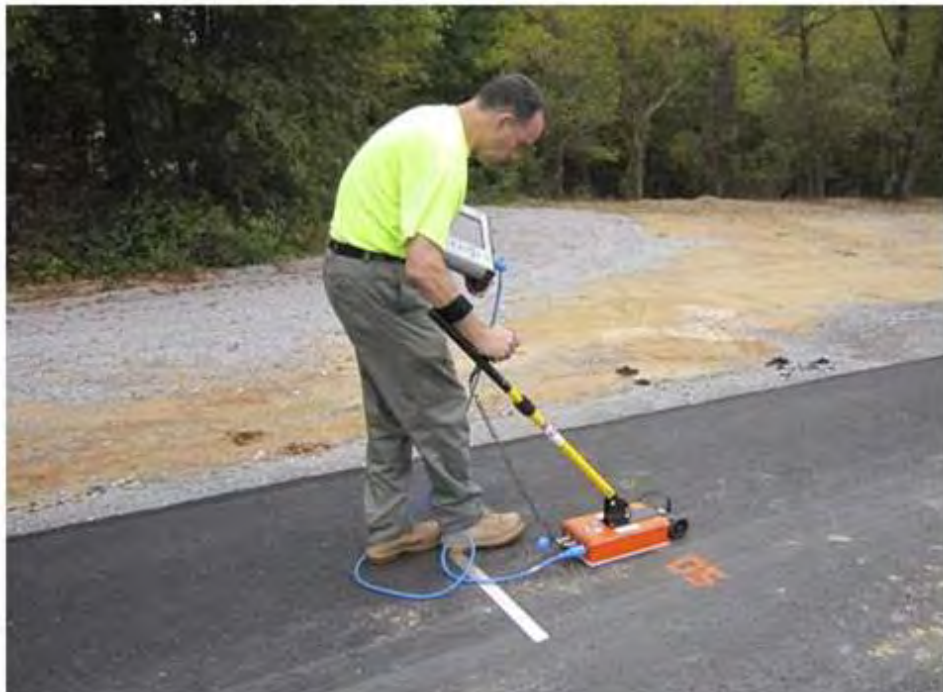
Figure 29. 900-MHz GSSI GPR system.

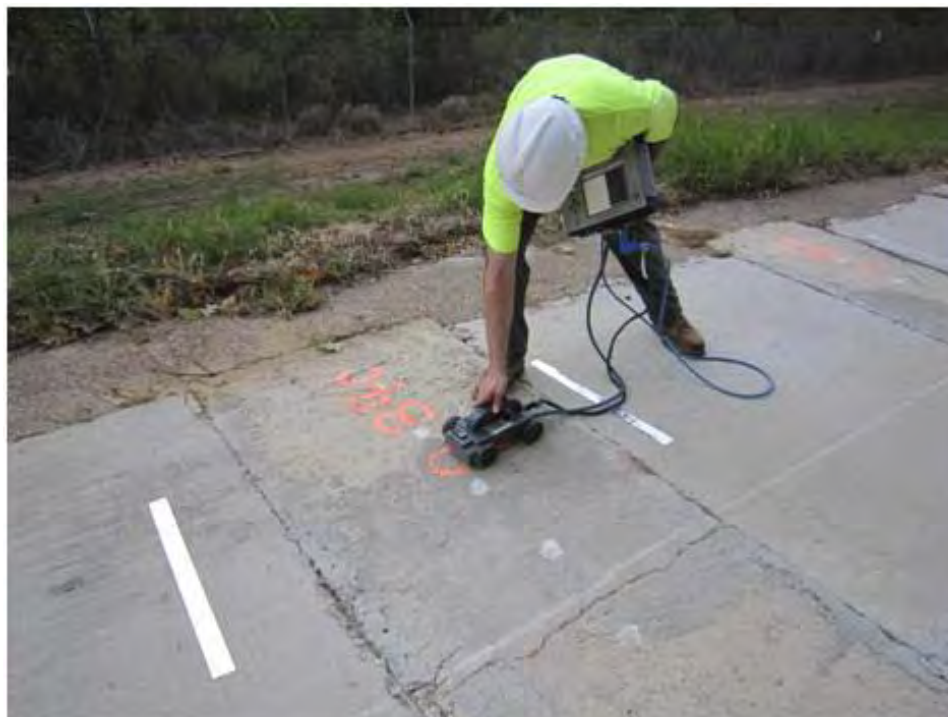
Figure 30. Testing with the 1.5-GHz GSSI antenna.

The 1.5-GHz GSSI ground-coupled antenna had wheels to assist with moving the antenna along the pavement, as shown in Figure 30. This antenna operates at a higher frequency than the previous one and will yield higher resolution but will not penetrate as deep. Testing took less than 30 sec per location for both antenna systems.

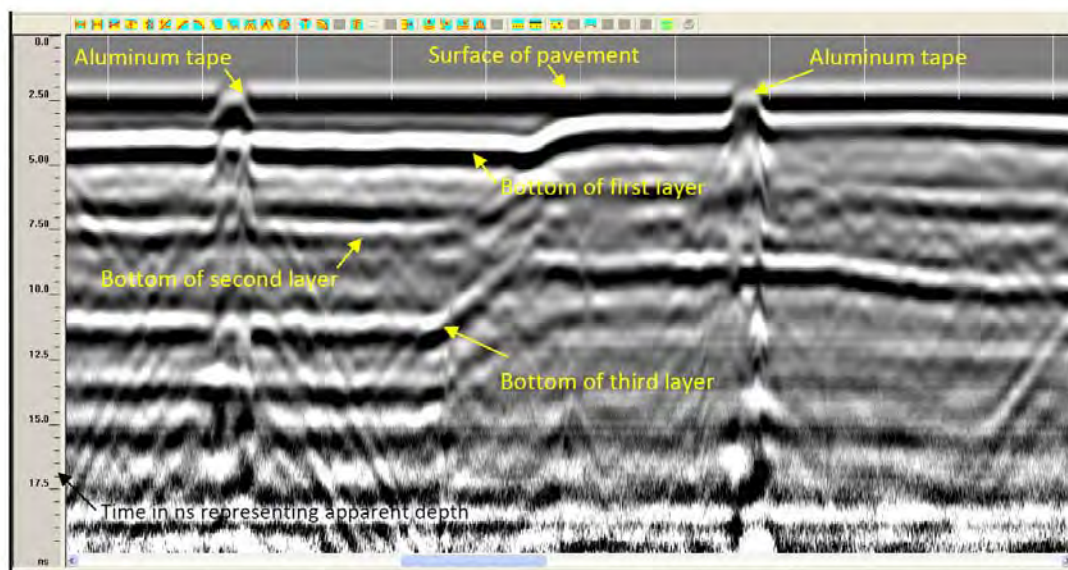
Figure 31. Example of data from the 900-MHz GSSI antenna.

Because both systems used were ground-coupled systems, dielectric constants were assumed for the initial thickness estimates. Resource International assumed a dielectric constant of 5 for the AC sections, and a dielectric constant of 9 for the PCC sections. Upon receiving the core data for the calibration data points, dielectric constants were calculated and found to be 4.92, 4.97, and 4.73 for AC test locations 10, 21, and 26c; and dielectric constants were calculated and found to be 9.40, 8.25, and 9.50 for PCC test locations 11c, 34c, and 40c, respectively. These new dielectric constants were applied to those test locations of similar material to provide a more accurate estimate of thickness.

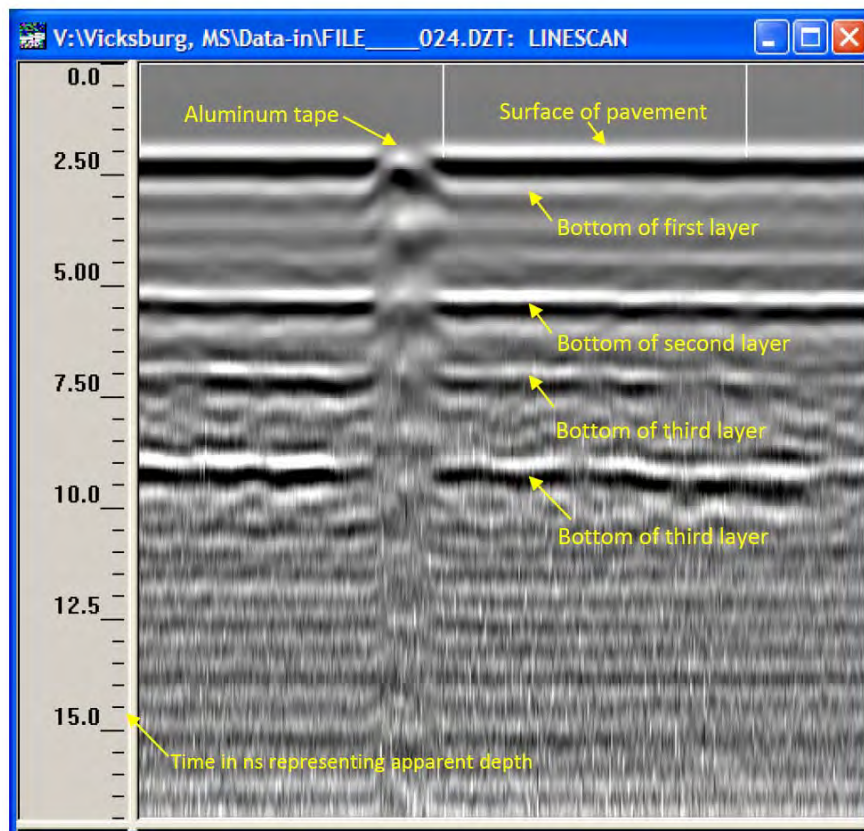
Figure 32. Example of data from the 1.5-GHz antenna.

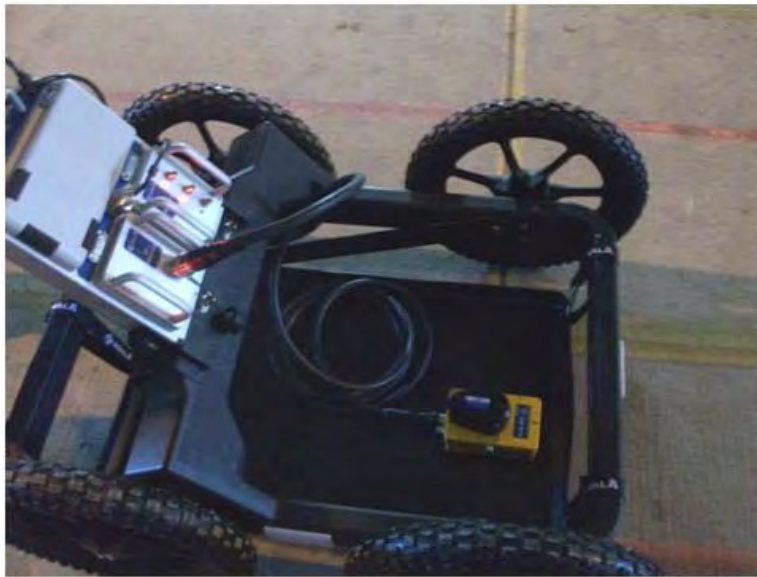
Figure 33. MALÅ equipment on a utility cart.

Setup required approximately 30 min and consisted of assembling the cart and connecting the cables. The utility cart, shown in Figure 33, is a generic cart used to hold antennas of different sizes, the ProEx control system, and a laptop for data collection. This cart was easy to take apart and reassemble as needed. Initially, only one antenna was tested at a time, but after the initial setup, two antennas were tested at a time. The time to switch out the antennas was approximately 5 min. Once the antennas were in the cart and plugged in, testing was rapid (less than 1 min) as data were collected as soon as the cart was rolled over the testing location.
